Towards a new Methodology to Evaluate the Environmental Impact of a Marine Outfall Using a Lightweight AUV

Abstract—This paper describes a new methodology to analyze the effect of a marine outfall and its toxic waste on the surrounding submarine ecosystems, combining divers and a lightweight Autonomous Underwater Vehicle (AUV) deployed and controlled from a small recreational boat. The innovation here is twofold: a) the relatively low cost equipment and human resources used in the overall process and the subsequent minimization of human risks, b) the application of all the technology that implies the use of an autonomous vehicle in this particular application, (automatic geo-localization, accurate mission programming and execution, increasing mission time or diverse sensorial data collection). The process intends to go one step beyond the current methods employed to inspect marine industrial infrastructures, shipwrecks, geological or benthic zones of special interest, based on the participation of divers and, in some cases, Remotely Operated Vehicles (ROVs). The case study presented in this paper corresponds to the inspection of the sewage outfall in Palma de Mallorca, started aft

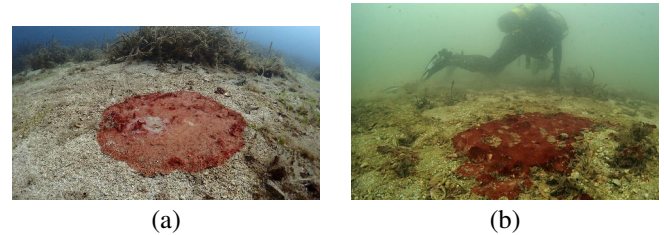
Fig. 1: Two images of the *Spirulina* found in the sea bed of Palma near the sewage pipe mouth. courtesy of Juan Poyatos Oliver *et al*

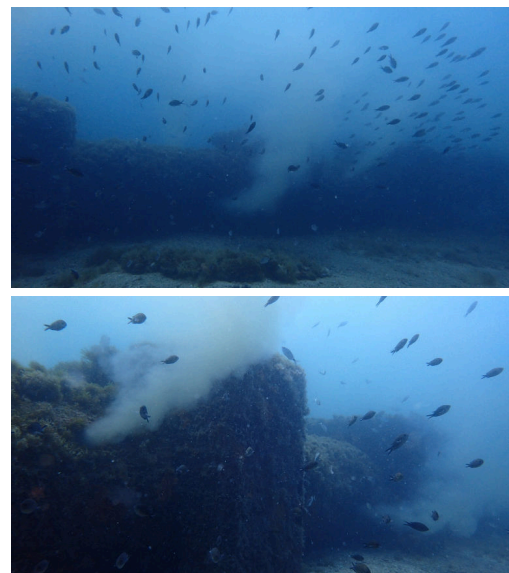
During the same immersion, some photos of the Palma sewage pipe revealed the existence of several holes in it, from which part of the water flow was flushing out without arriving to the mouth filters. Figure 3 shows two different views of two lateral holes in the sewage pipe. The recollection of this type of images is important to determine the state of the infrastructure and to prepare maintenance actions.

Fig. 3: Two images showing the Palma sewage pipe with two holes in it. Courtesy of Juan Poyatos Oliver *et al*.

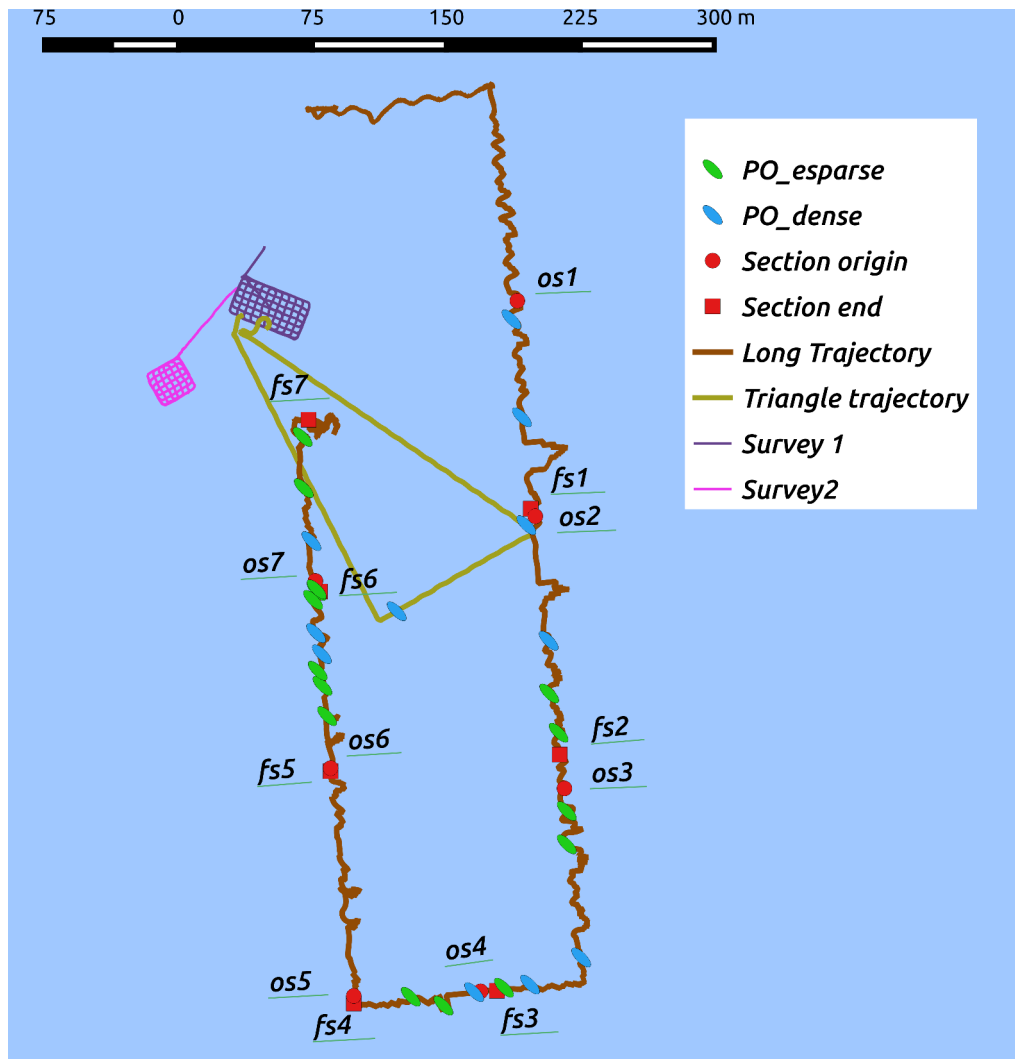
Figure 8 shows the detail of the covered trajectories estimated by the internal vehicle localization EKF filters which integrated all the aforementioned sensors. This figure also shows a summary of the obtained data. In order to facilitate the analysis of the longest trajectory, this was divided in 7 consecutive sections. For each section, its respective photo-mosaic was built to evaluate the state of the bottom. Red circles and red squares mark the origin and the end, respectively, of the 7 different sections. Origins are labeled with the text *osi* and ends with *fsi*. For instance, the red circle labeled with *os1* indicates the origin of the section 1, while the rectangle labeled with *fs1* indicates the end of the section 1, and so forth. One of the important descriptors of Posidonia meadows is its bottom coverage [13]. A high density of seagrass in an extend area of the bottom indicates a meadow in a good condition while low coverages with disperse spots of seagrass indicate a clear regression or a high mortality. Then, blue ellipses of figure 8 mark areas with a relatively high density of P.O. while green ellipses indicate areas with a sparse presence (low density) of P.O.. The rest of the trajectory corresponds to areas with sand and fragments of dead seagrass. All these information was obtained by visual inspection, observing the video sequences and analyzing the photo-mosaics of each section and of the different datasets. Figure 9 shows the photo-mosaic of the area viewed during the pink survey. This mosaic evidences the lack of any live, neither P.O., nor other species of algae or fish, only sand and rests of dead matte.

Several important conclusions can be inferred by observing figures 8 and 9: a) the P.O. bottom coverage is irregular and disperse in the majority of the inspected areas; b) the first surveys revealed areas completely barren; c) the P.O. distribution suggests a clear regression towards the pipe mouth, but it does not permit to draw any limit, yet, between *dead* o *alive* zones; additional inspections are needed.

Fig. 8: Vehicle trajectories with the relevant observed data. Red circles and red squares indicate, respectively, the origin and ends of the different trajectory sections. Blue and green ellipses indicate areas with high and low density of Posidonia.

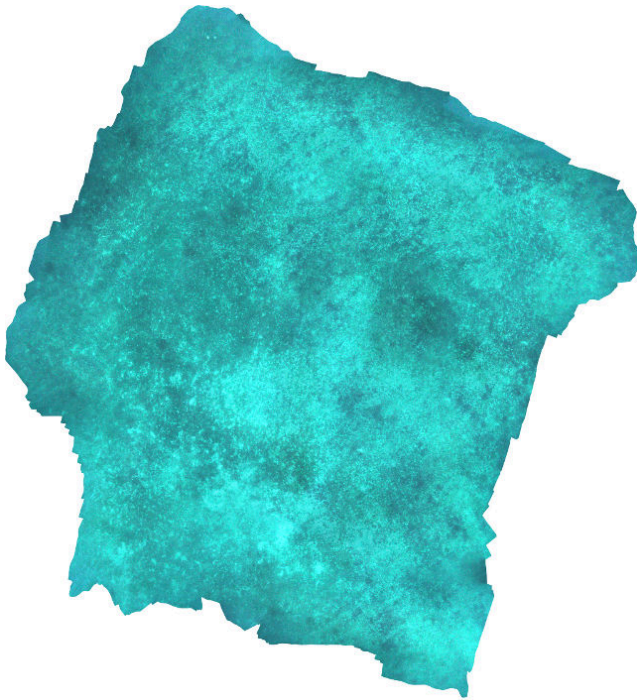
Since P.O. usually forms very dense meadows when the environmental conditions are optimal, all the analyzed sections reveal a clear regression of this specie in a still undefined area nearby the sewage pipe. The bottom coverage of P.O. is null in the pink and blue squared surveys, and in the triangular yellow trajectory, except in both distant vertex, and so is the presence of any other living beings. However, the brown trajectory shows some more areas with sparse spots combined with areas of a denser concentration of P.O..

Fig. 9: Photo-mosaic of the pink squared survey.

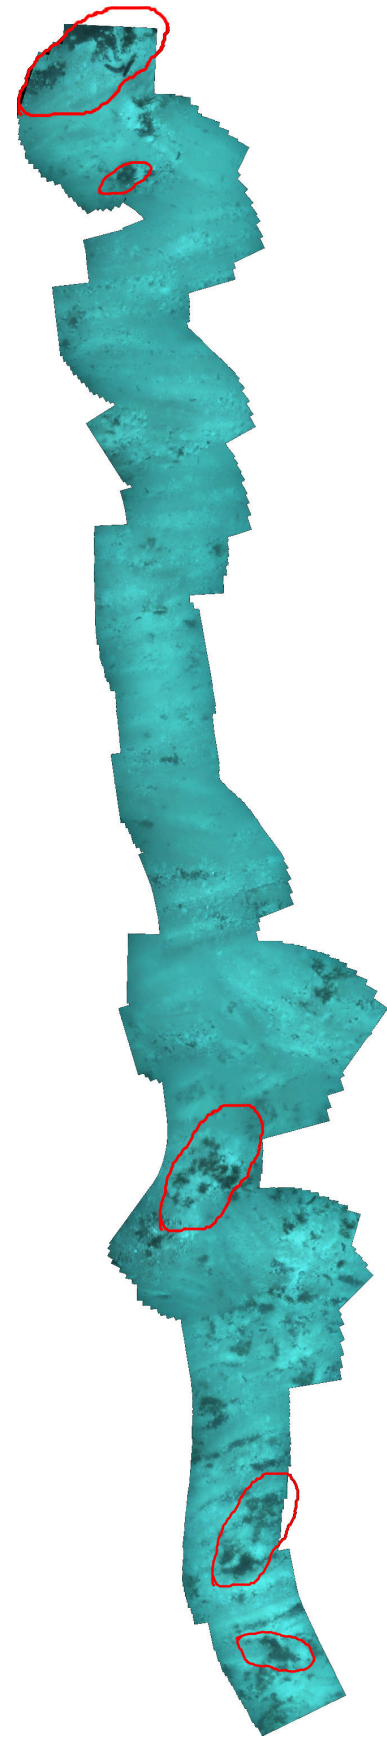
Figure 10 shows the photo-mosaic obtained from images taken in sections 5. This mosaic was formed by 501 key frames and covers 150 meters of trajectory, approximately. In this area, the bottom is formed mainly by sand, dead seagrass and a few spots of alive P.O., marked in red circles.

Fig. 10: Mosaic of section 5.

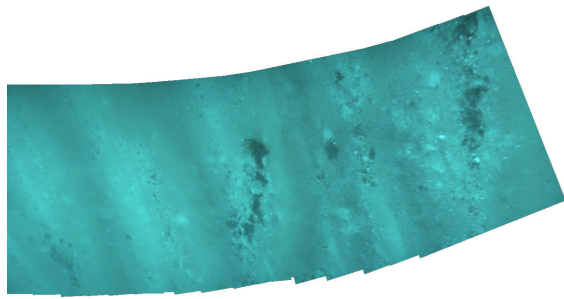
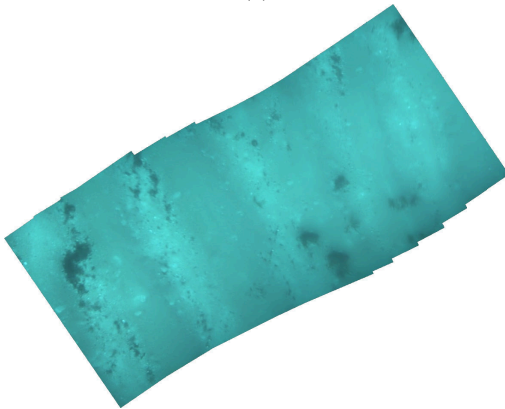
Fig. 11: Sub-mosaics of to two different portions of section 5.

Figure 11 shows two portions of the mosaic of section 5 (from image number 269 to 373), as a sample of a *dead* zone. Both figures were built with only 14 images, covering, approximately, between 6 and 7 meters of the trajectory. The clear areas correspond to sand, while the sparse black spots

correspond to some rests of dead matte. Figure 12 shows two mosaics of two different portions of section 2, as a sample of a zone where the P.O. still occupies the bottom with a relatively high density. Both figures were composed with 21 images, between the number 242 and 261 and from the 303 to the 325, covering, approximately, 7 meters of the aforementioned trajectory, each one. In both mosaics, the darker areas correspond to the alive P.O. while the clearer areas correspond to sand. Although the density of P.O. is not as it is usual in healthy meadows, the presence of seagrass is quite significant here.

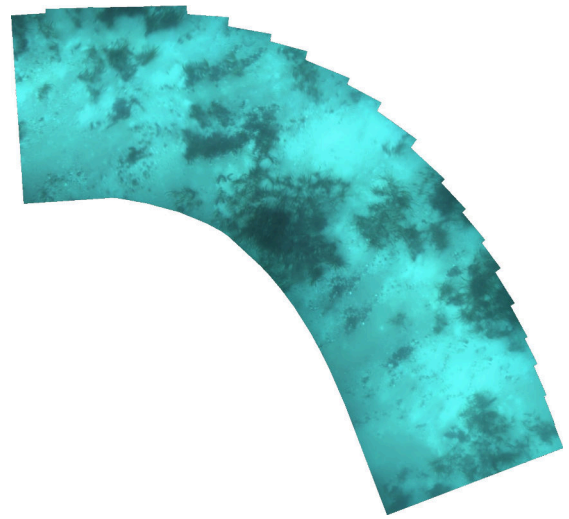
Finally, figures 13 and 14 show two mosaics of other two portions of section 2, where the presence of P.O. is sparse. The first mosaic was formed with 17 frames (from image 396 to 413), covering 5 meters of the second section, while the second one was build from the first 65 images of the sequence, covering 20 meters, approximately. In these mosaics, it is difficult to distinguish between the dead matte (see some samples marked in red) and the rests of alive P.O., (see some samples marked in blue).

Fig. 13: A mosaic of a portion of section 2.

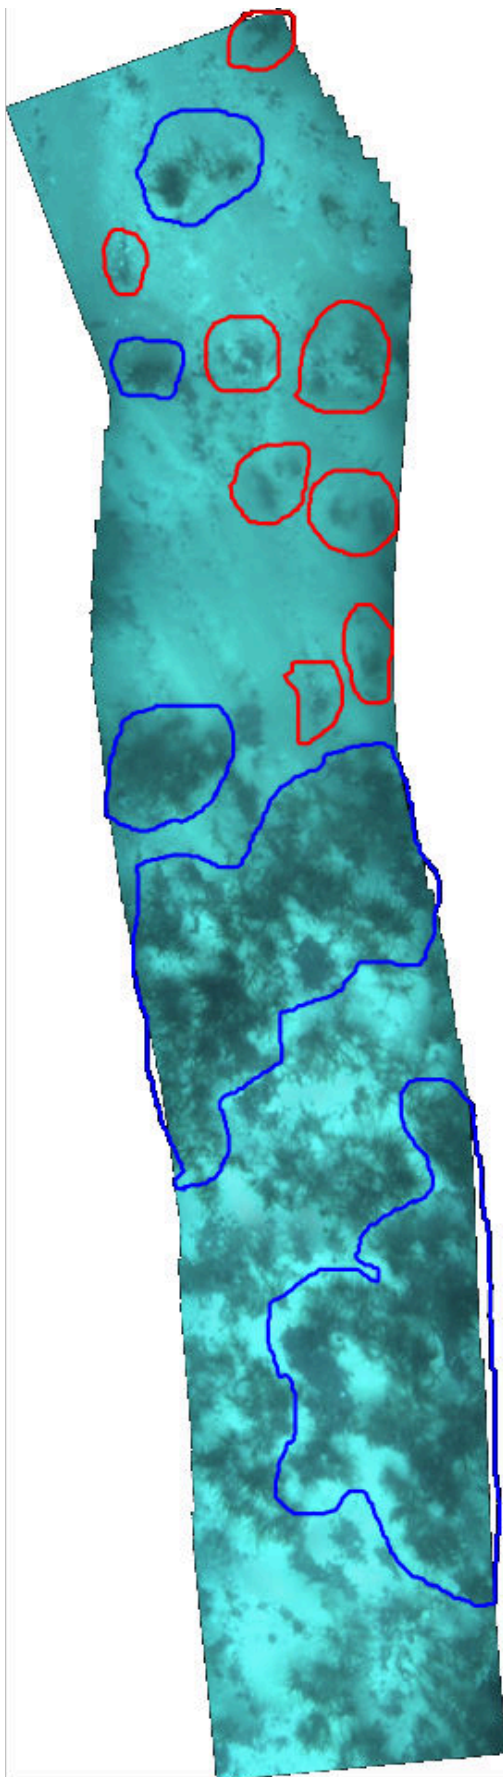
Fig. 14: A longer mosaic of a portion of section 2.
