Towards a new Methodology to Evaluate the Environmental Impact of a Marine Outfall Using a Lightweight AUV

Abstract—This paper describes a new methodology to analyze the effect of a marine outfall and its toxic waste on the surrounding submarine ecosystems, combining divers and a lightweight Autonomous Underwater Vehicle (AUV) deployed and controlled from a small recreational boat. The innovation here is twofold: a) the relatively low cost equipment and human resources used in the overall process and the subsequent minimization of human risks, b) the application of all the technology that implies the use of an autonomous vehicle in this particular application, (automatic geo-localization, accurate mission programming and execution, increasing mission time or diverse sensorial data collection). The process intends to go one step beyond the current methods employed to inspect marine industrial infrastructures, shipwrecks, geological or benthic zones of special interest, based on the participation of divers and, in some cases, Remotely Operated Vehicles (ROVs). The case study presented in this paper corresponds to the inspection of the sewage outfall in Palma de Mallorca, started aft

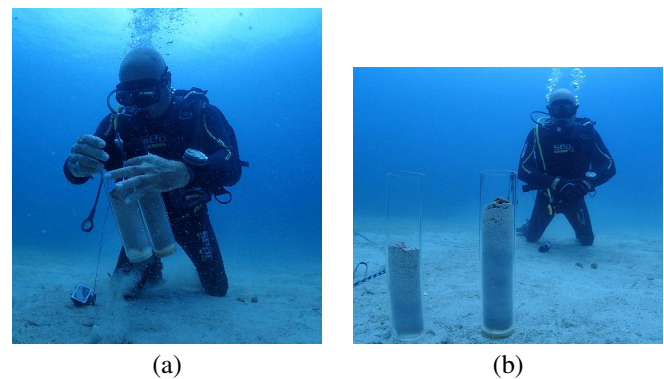
Fig. 2: Two images of the divers taken samples of sand and a water column *in situ*. Courtesy of Juan Poyatos Oliver *et al*

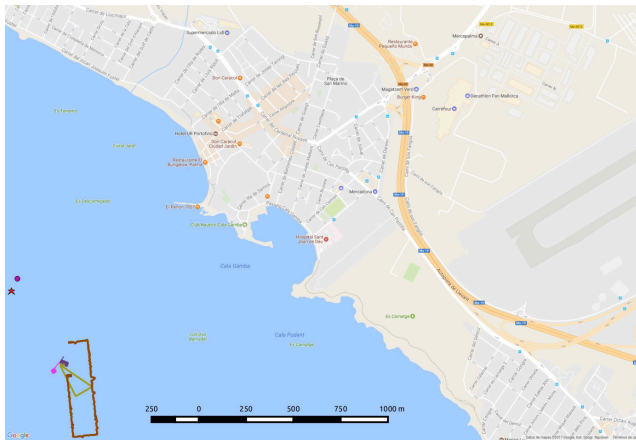
Fig. 7: The inspected area with some of the missions.

Figure 7 shows the exact location of the explored area, where the cyan dot corresponds to the pipe mouth, the red star corresponds to the whirlpool caused by the emission of the wasted water, and the 4 surveys conducted by the vehicle are depicted in pink, blue, yellow and brown. All missions started at approximately 400 meters from the whirlpool. It is assumed that the sewage spill does not affect the immediate area located just by the mouth pipe, since, the pollutant material is flushed away with force, being deposited at a certain distance. The *Spirulina* was found at an approximate distance of 400 meters away from the pipe mouth.
